NASA Electronic Parts and Packaging (NEPP) Hermeticity Task Overview

NEPP Program Task 13-294: Hermeticity Correlation Study

NASA MSFC/GSFC

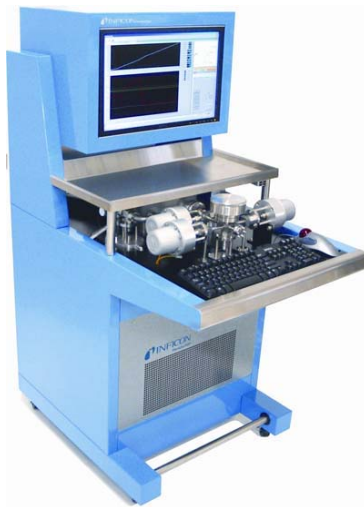
CHLD
(Pernicka 700H System)

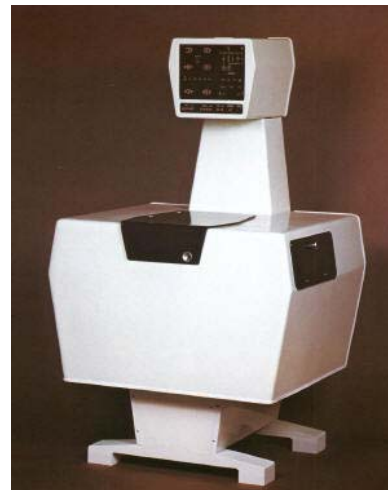
Krypton-85
(IsoVac Mark V Bomb Station)

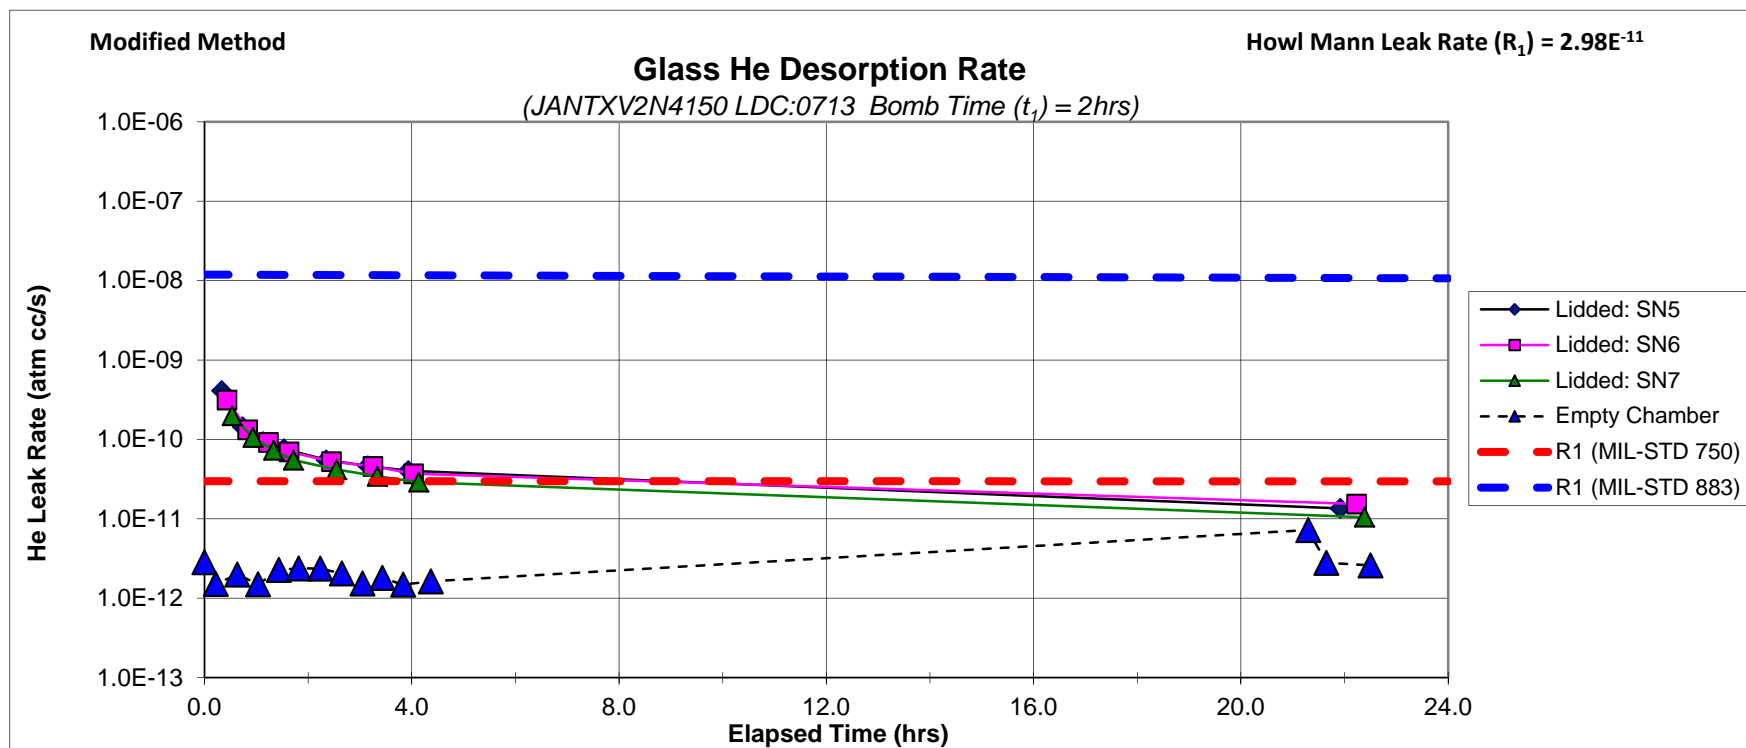
- **Three JANTXV2N4150 LDC0713 transistors tested**
 - **L1 = 5×10^{-9} atm cc/s (air), Bomb pressure = 60 psig, Bomb time 2 hours, Volume = 0.22 cc**
 - **Howl Mann He leak rate limit for these conditions:**
 - **$R_1 = 2.98 \times 10^{-11}$ atm cc/s for 0 hour dwell time**
 - **$R_1 = 2.97 \times 10^{-11}$ atm cc/s for 24 hour dwell time**
- **Glass He desorption rates (atm cc/s He)**
 - **After ~4 hours: 2.90×10^{-11} to 4.03×10^{-11} (Empty chamber: 1.63×10^{-12})**
 - **After ~24 hours: 1.05×10^{-11} to 1.54×10^{-11} (Empty chamber: 2.59×10^{-12})**

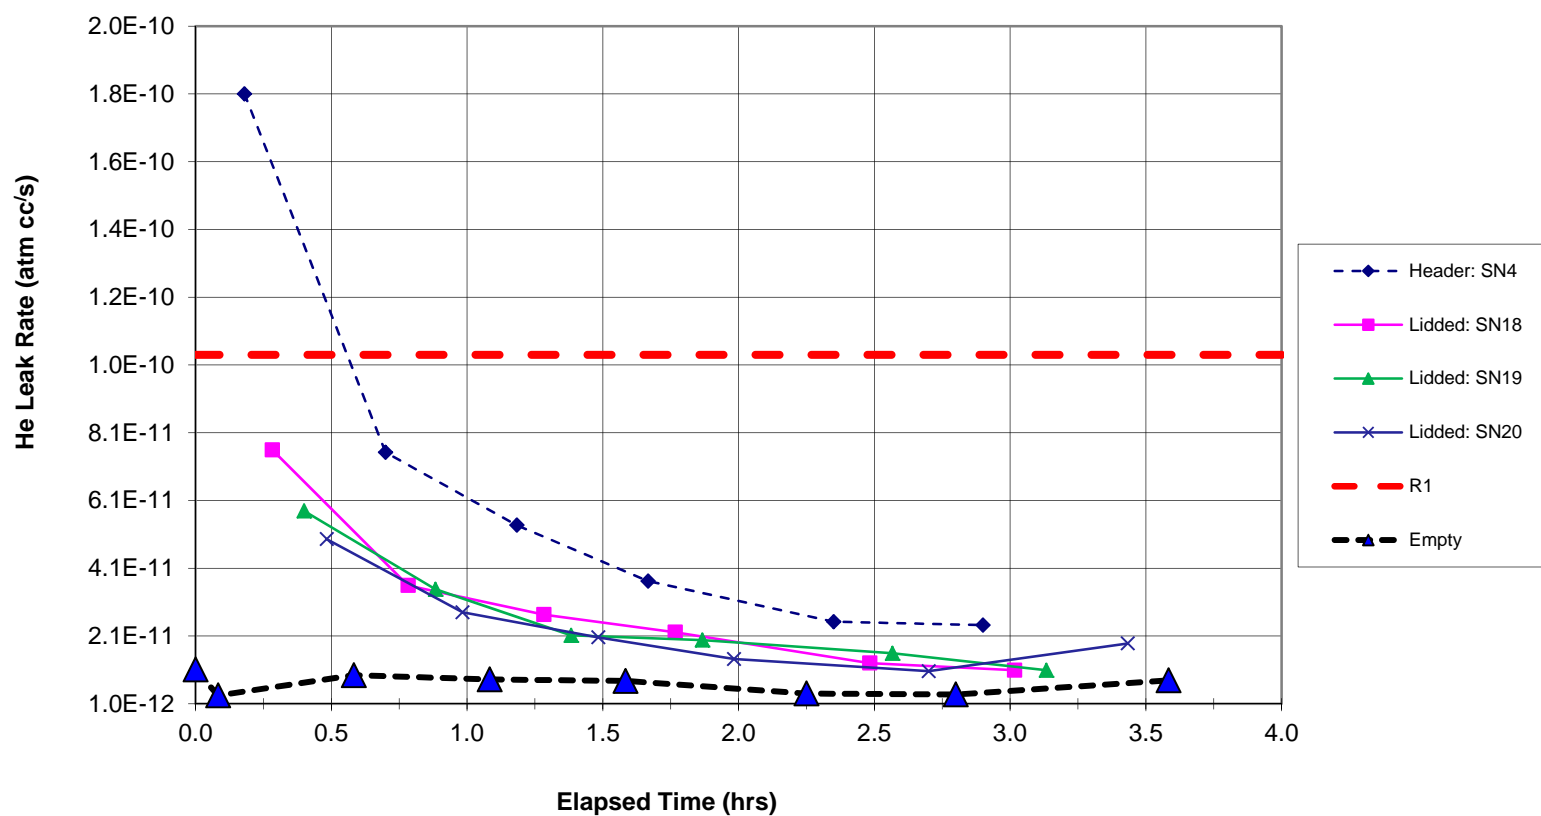
Method: 20/5/50/50/5
(Lidded Device)

Glass He Desorption Rate
(IR TO-39: Bomb Time (t_1) = 4hrs)

Howl Mann Leak Rate (R_1) = $1.04E^{-10}$
($L=5.00E^{-9}$; $P_e=74.7psia$; $V=0.126cc$; $t_1=4hr$)

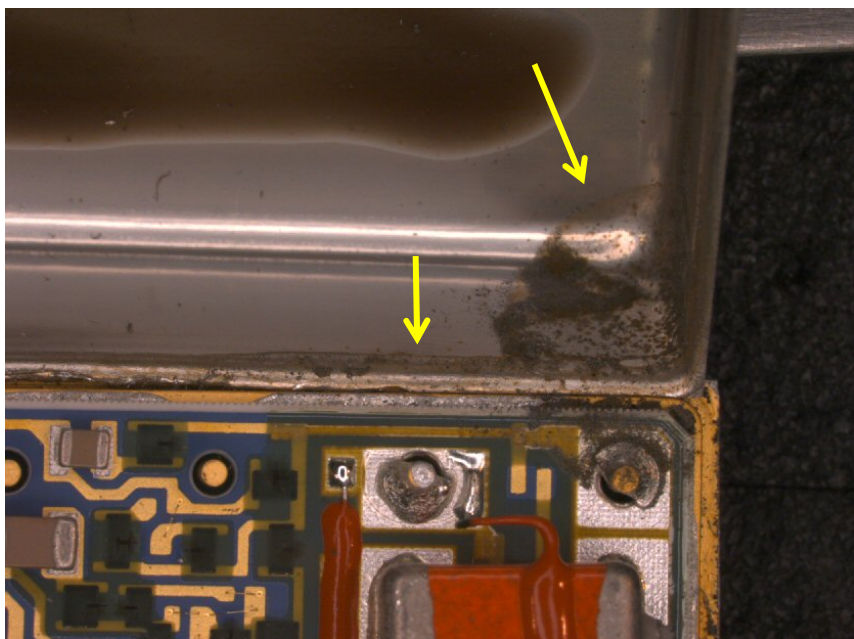
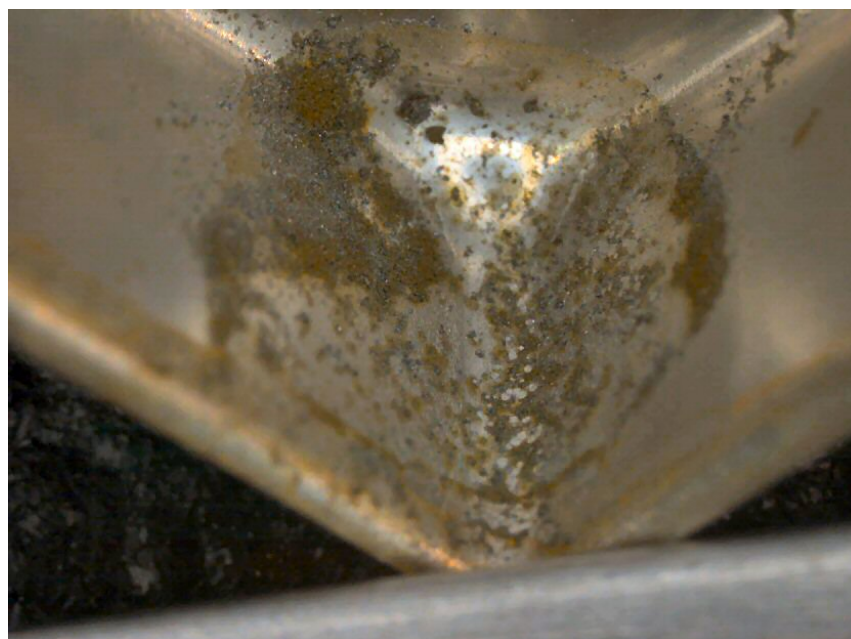
Sample M – Lid

Evidence of corrosion along the edge and inside corner of the device lid

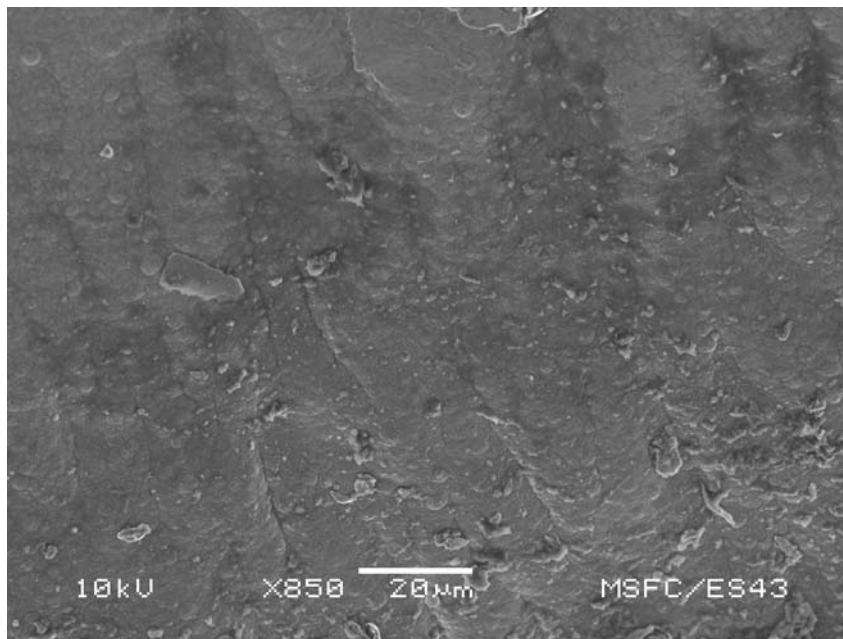
Sample M – Lid

Examination of corrosion area along the edge of the device lid

Darker areas indicate smaller molecular weight material typical of corrosion products

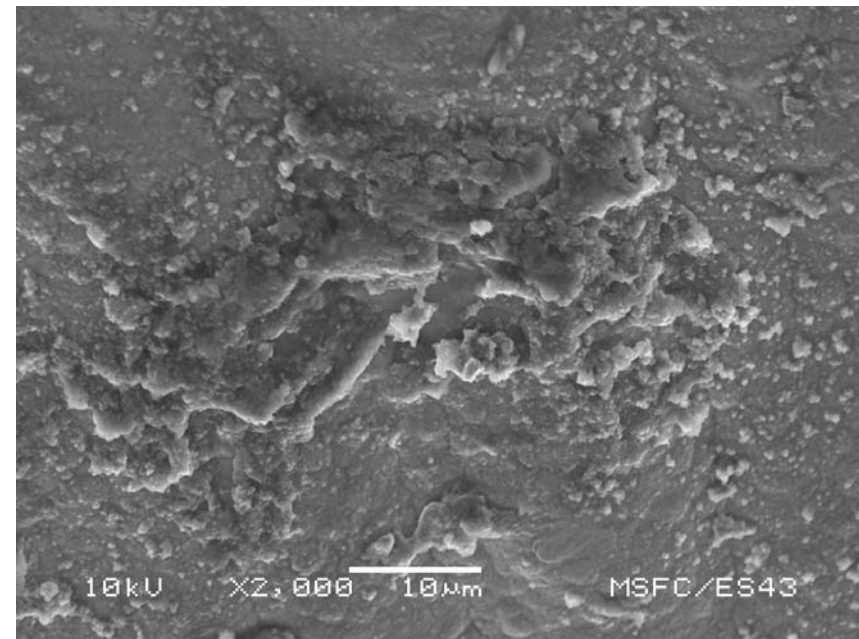
Raised areas indicate corrosion

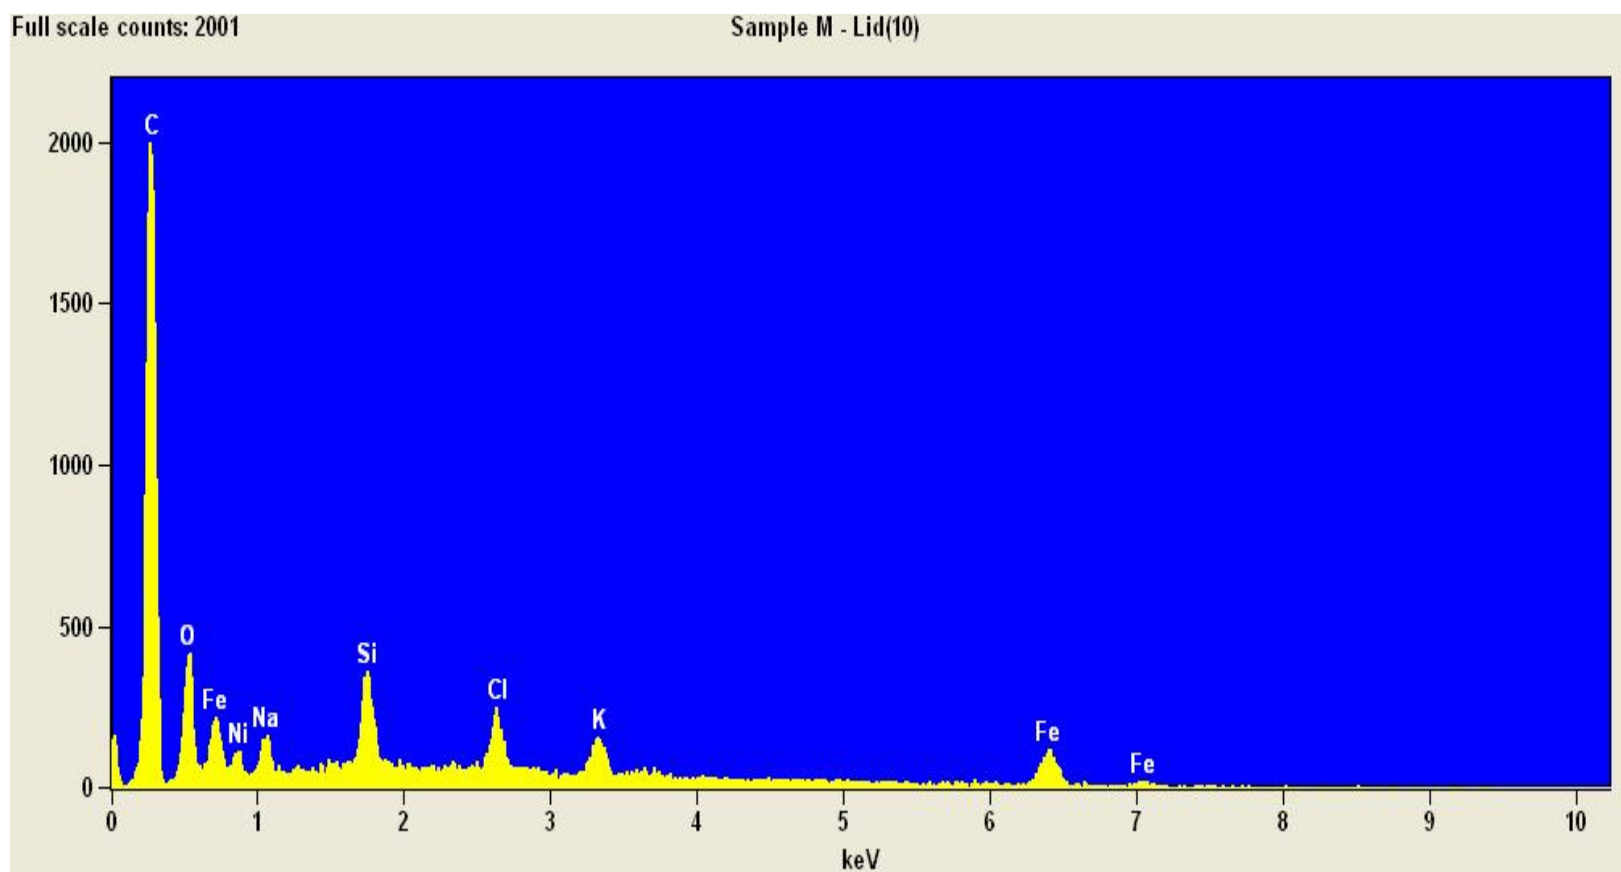
Sample M – Lid

Elemental analysis provides evidence of ionic contamination and corrosion

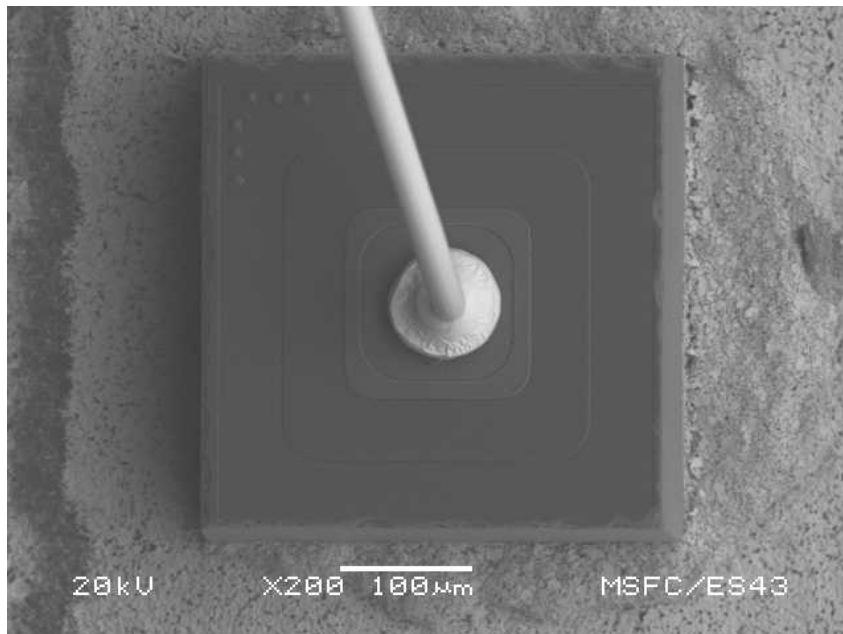
Sample U

Examination of a representative Ag_2S corrosion area

Die and bond area at low magnification

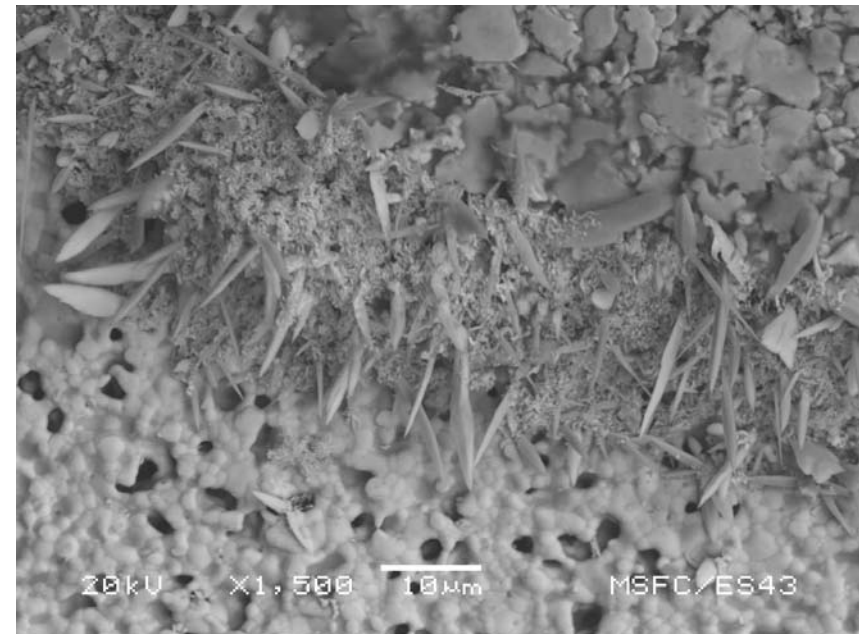
Evidence of heavy growth of Ag_2S along Ag die attach edge and bond pad

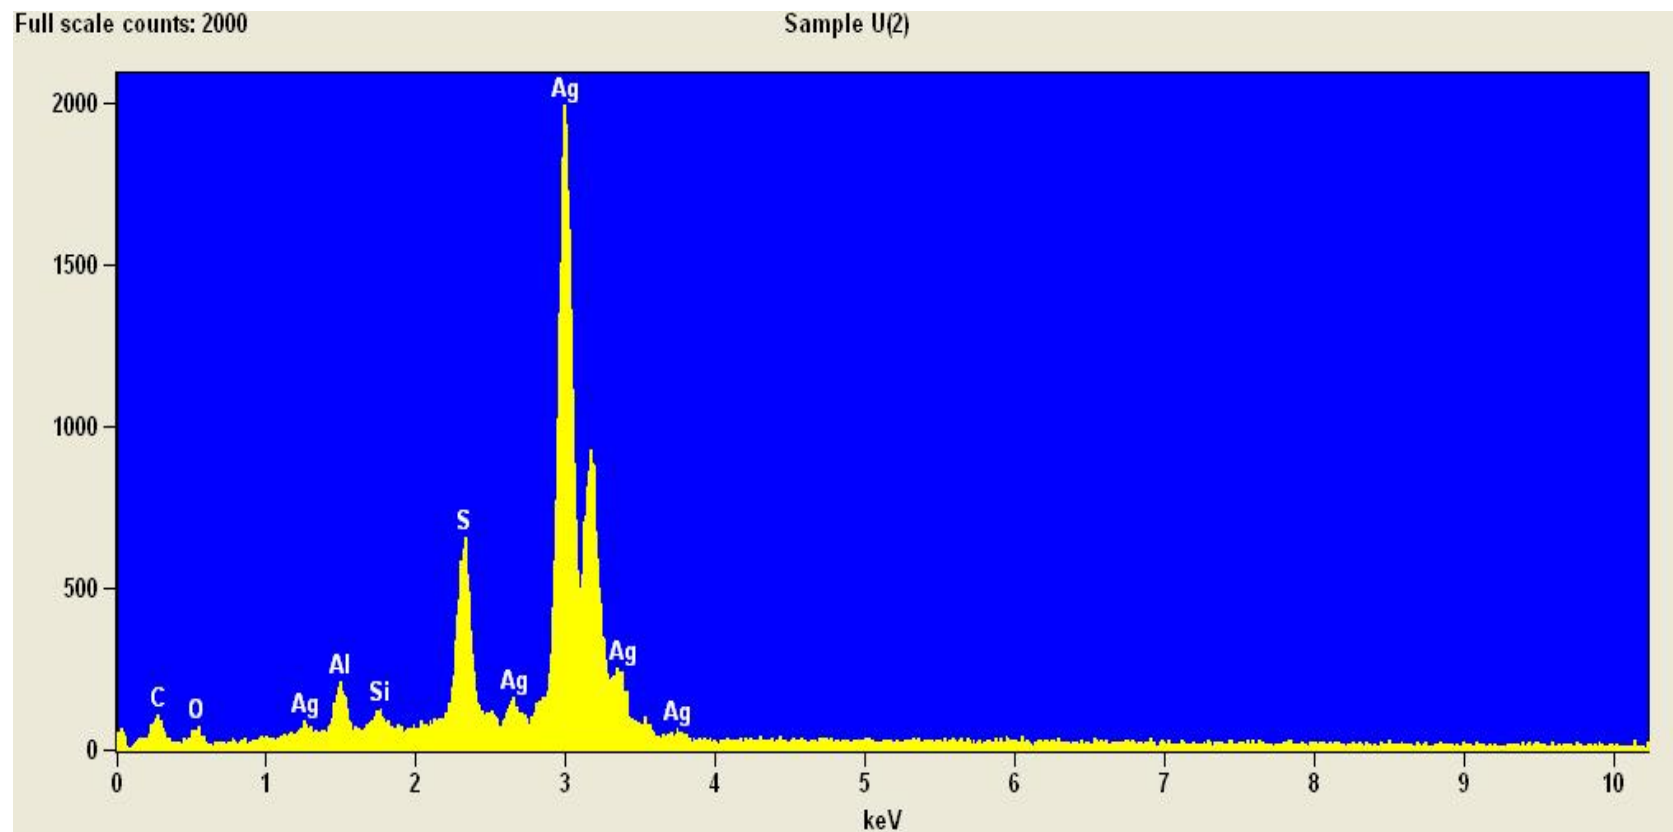
Sample U

Elemental analysis provides evidence of Ag_2S corrosion

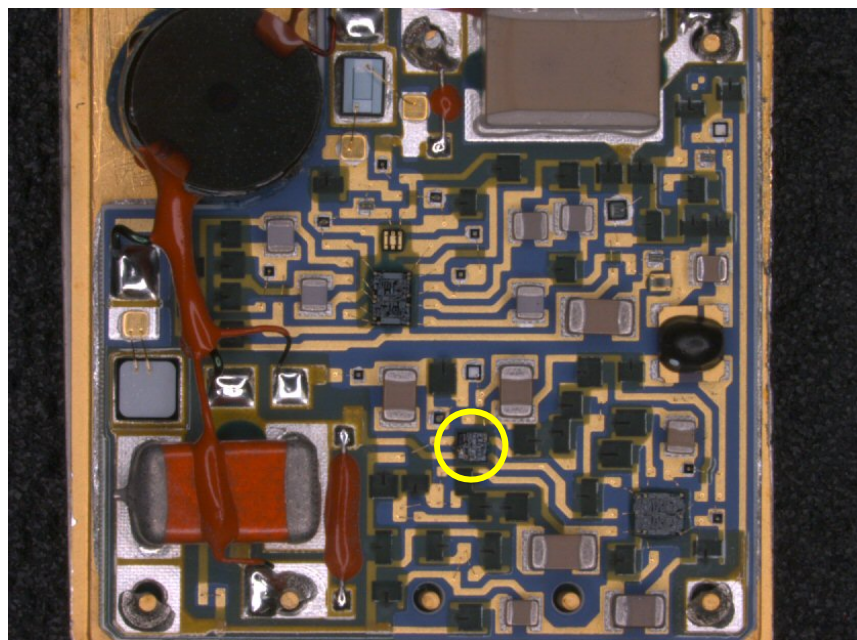
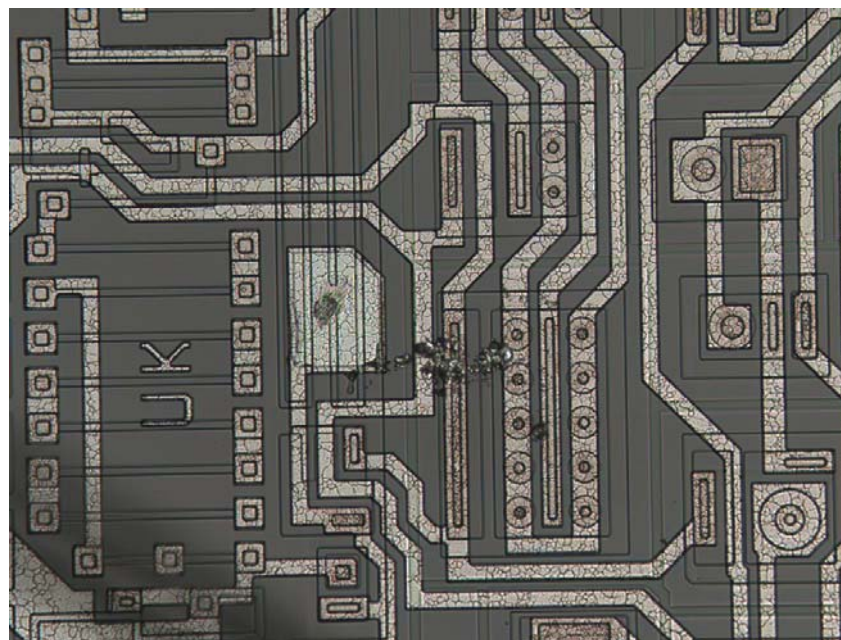
Sample C

Device found with presence of Ag_2S corrosion on top of passivation

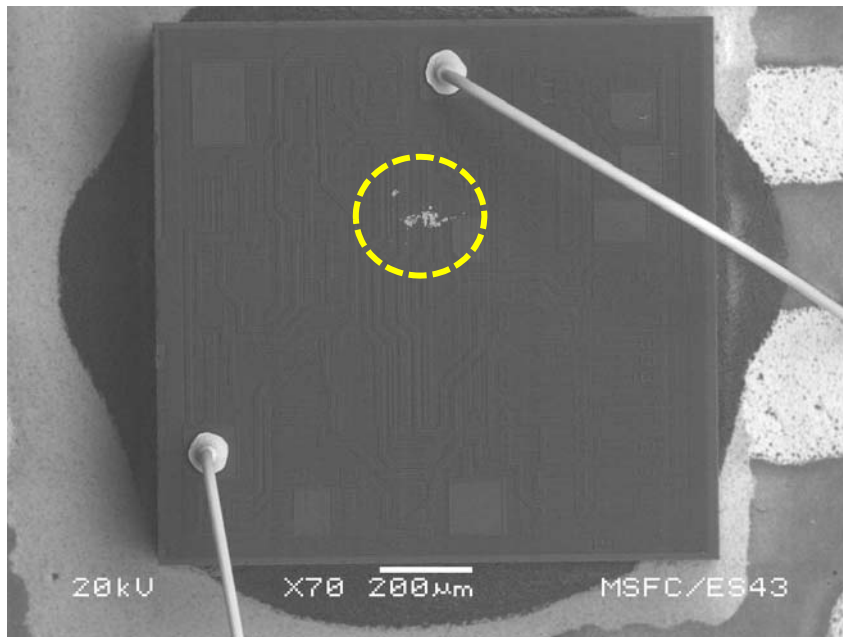
Sample C

Examination of Ag_2S corrosion area on top of passivation layer

Lighter area indicates a higher molecular weight material than silicon passivation

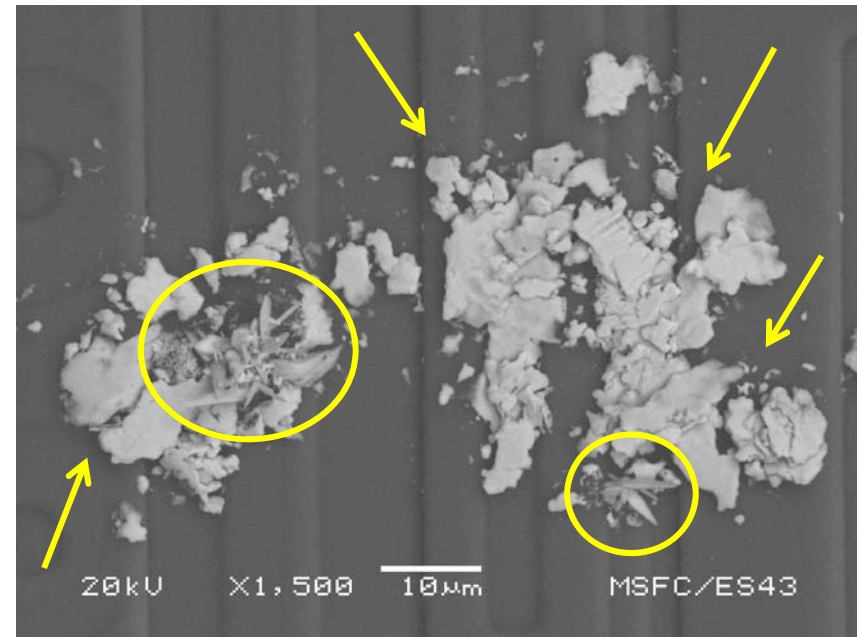
Shape of particles are consistent with silver die attach (arrows) and Ag_2S corrosion (circled)

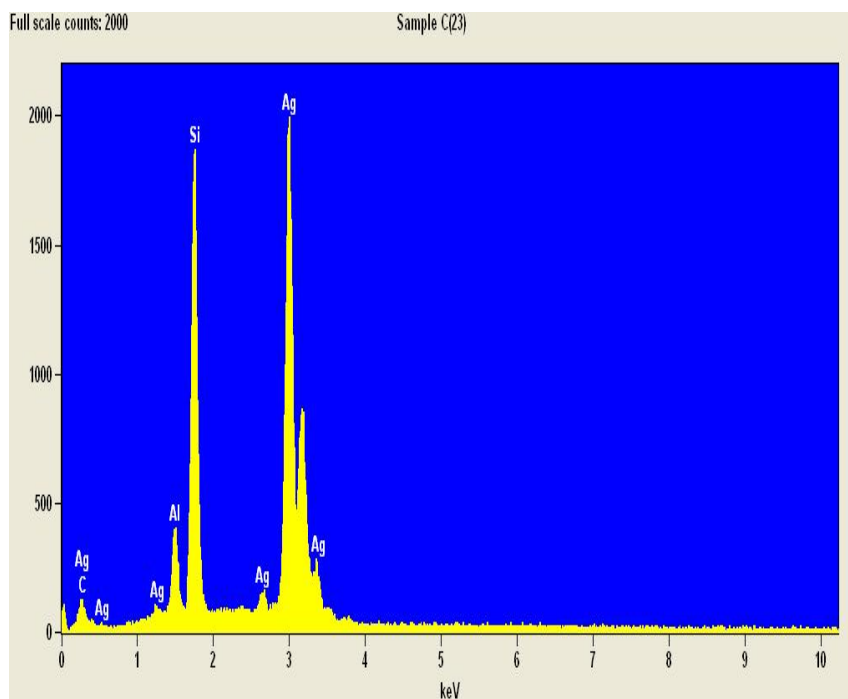
Sample C

Elemental analysis of materials on die surface

Spectrum of Ag die attach particles

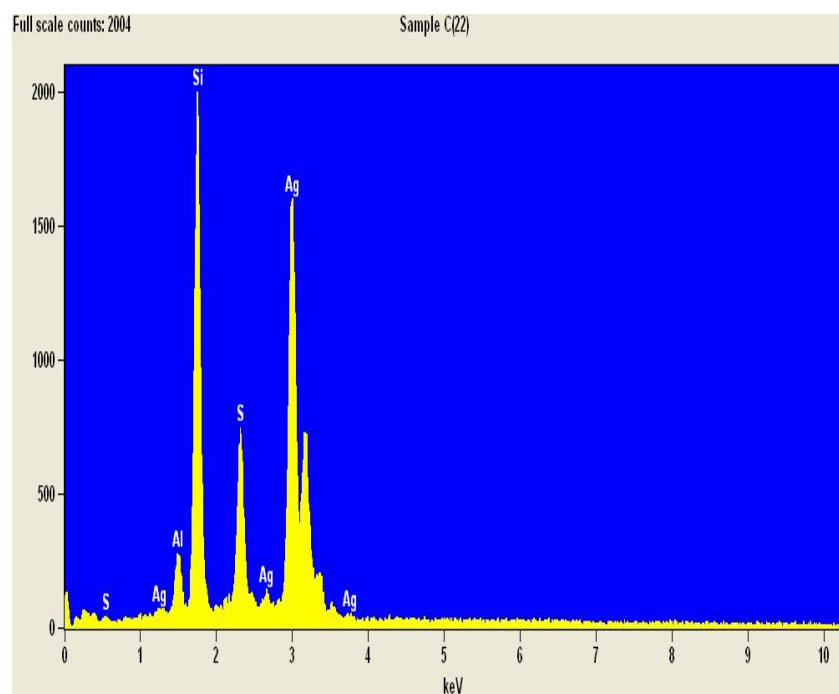
Spectrum of Ag_2S corrosion

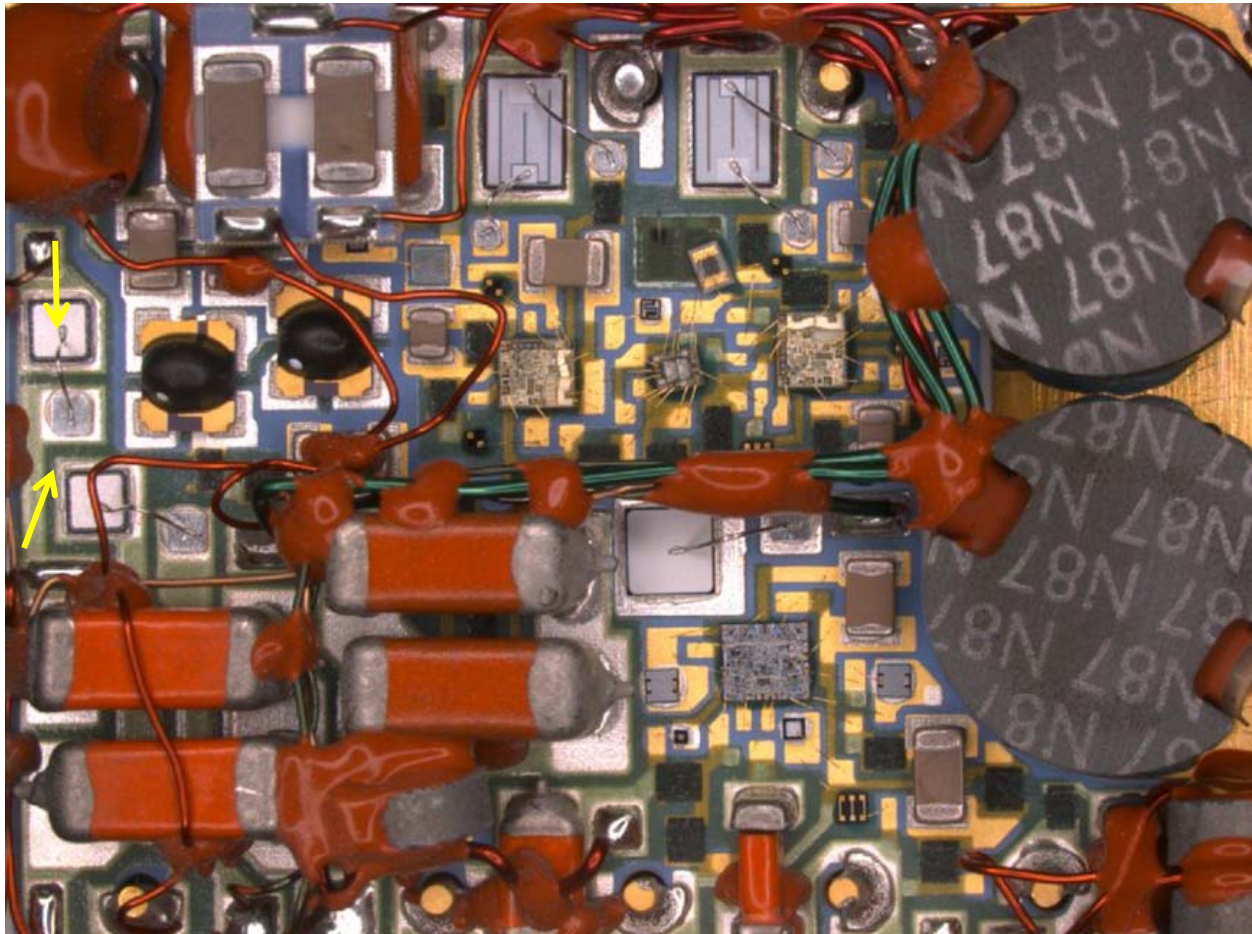
Sample Q

Devices inspected for the presence of Ag_2S corrosion

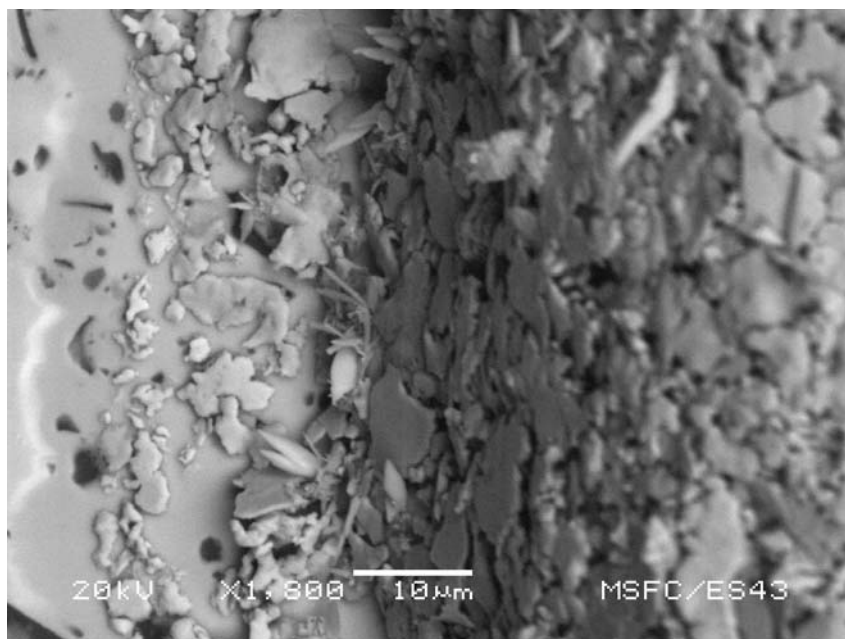
Sample Q

Examination of Ag_2S corrosion on two diodes

Diode 1 shows light Ag_2S corrosion forming on die attach

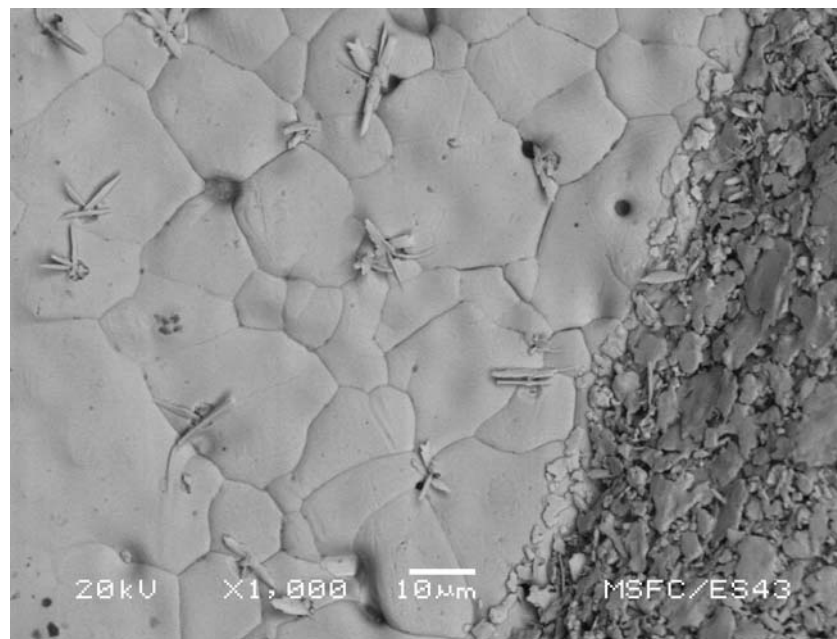
Diode 2 shows light Ag_2S corrosion forming on board bond pad and die attach

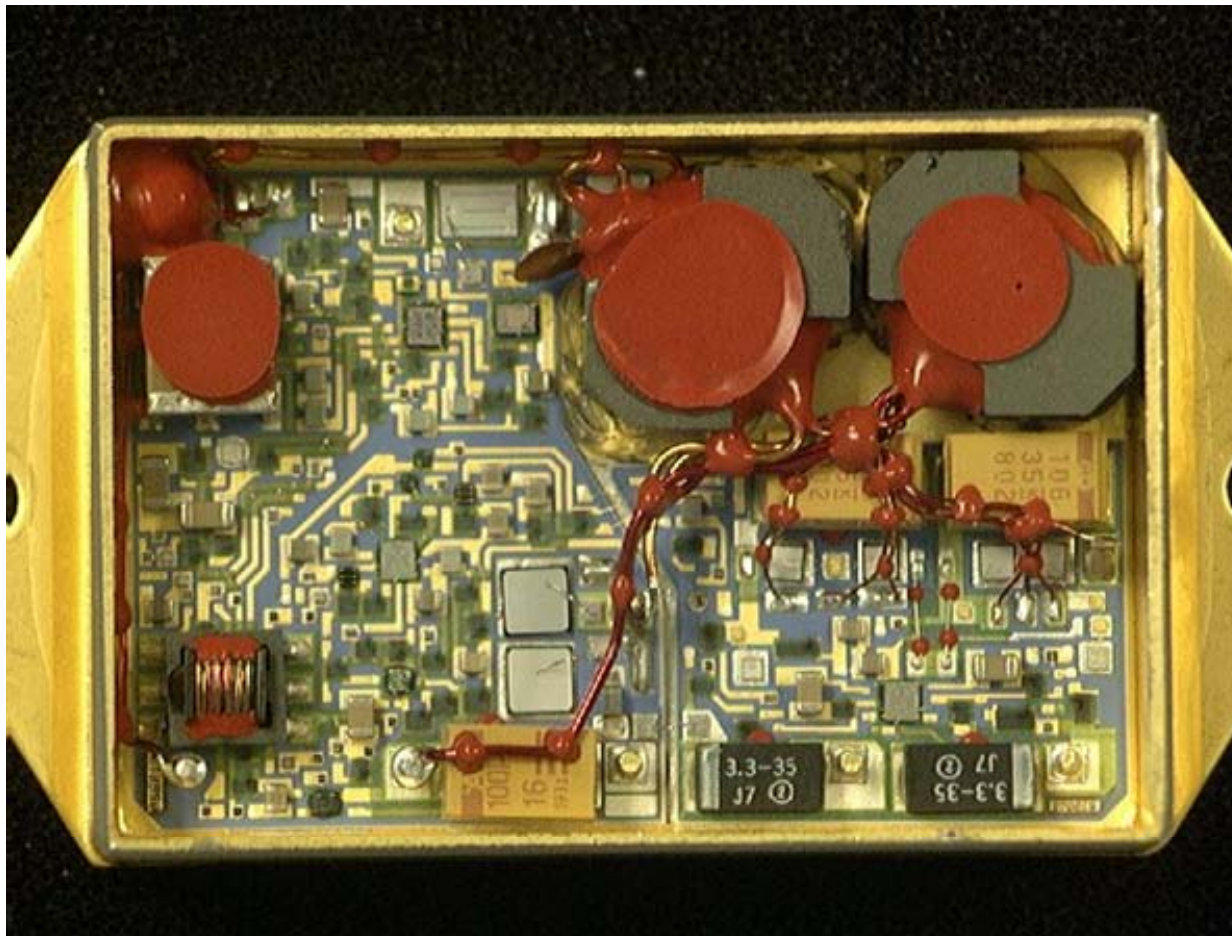
Control Sample

Inspected devices for evidence of Ag_2S corrosion

- Passed MIL-STD-750 Kr85 leak tests and showed no evidence of corrosion

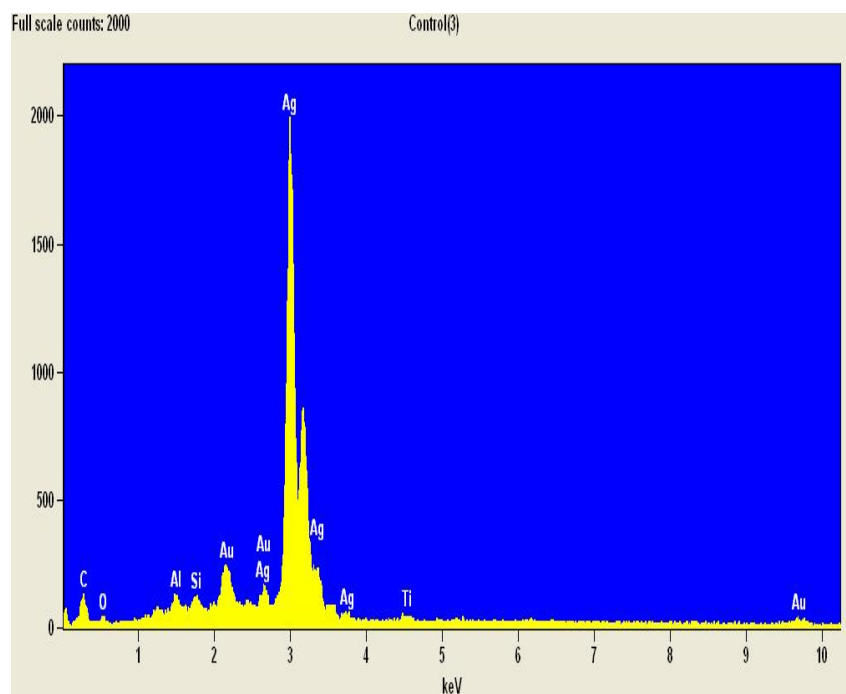
Control Sample

Elemental analysis of two representative areas show no signs of Ag_2S corrosion

Spectrum of stacked capacitor Ag die attach

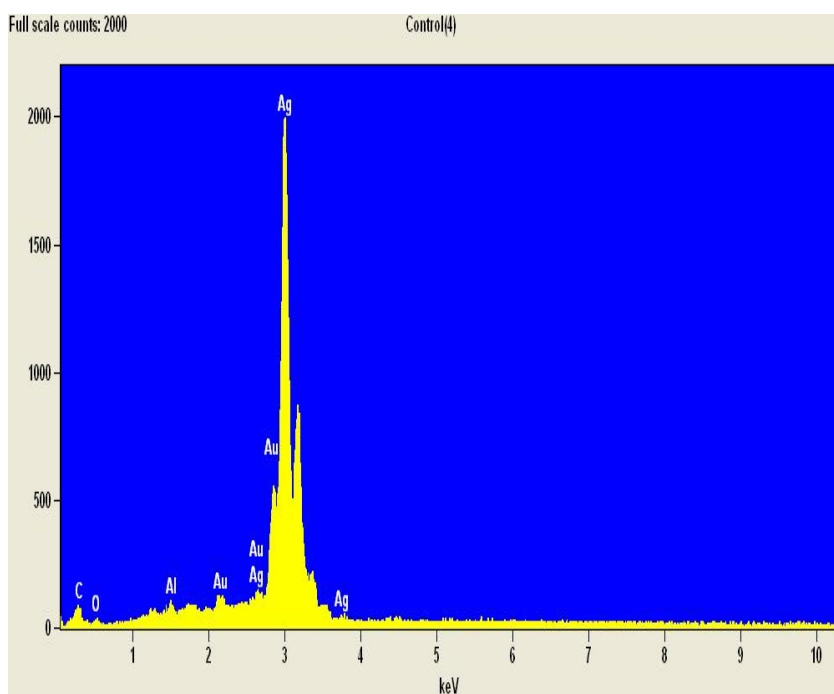
Spectrum of a diode Ag die attach
